Ambient Groundwater Quality of the Sacramento Valley Basin: An ADEQ 1999 Baseline Study

---Douglas Towne and Maureen Freark Maps by Larry W. Stephenson ADEQ Fact Sheet 01-10 September 2001

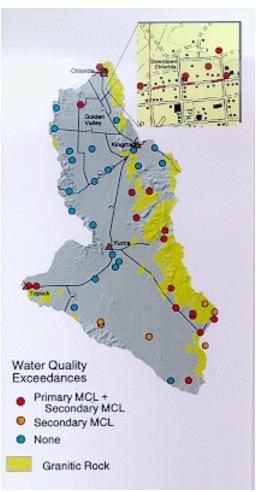
Figure 4. Water quality exceedances most commonly occur near the town of Chloride, in granitic areas of the Hualapai Mountains, and in downgradient areas of the basin near Topock.

This study was conducted by the ADEQ Groundwater Monitoring Program which is authorized by the legislative requirement in Arizona Revised Statute §49-225 to monitor the quality of the state's groundwater. To characterize regional groundwater quality, 48 sites (**Figure 4**) were sampled for inorganic constituents (field parameters, general mineral characteristics, major ions, nutrients, and trace elements), volatile organic compounds (VOCs), perchlorate (a man-made inorganic salt), and isotopes of hydrogen, oxygen, and nitrogen. At 40 sites, samples were also collected for radiochemistry analyses.

be a health concern (3). Of the 48 sites sampled, 28 exceeded Secondary MCLs including total dissolved solids or TDS (24 sites), fluoride (16 sites), sulfate (7 sites), chloride (7 sites), manganese (3 sites), and iron (2 sites) (**Figure 4**).
